## Differential reconditioning part two

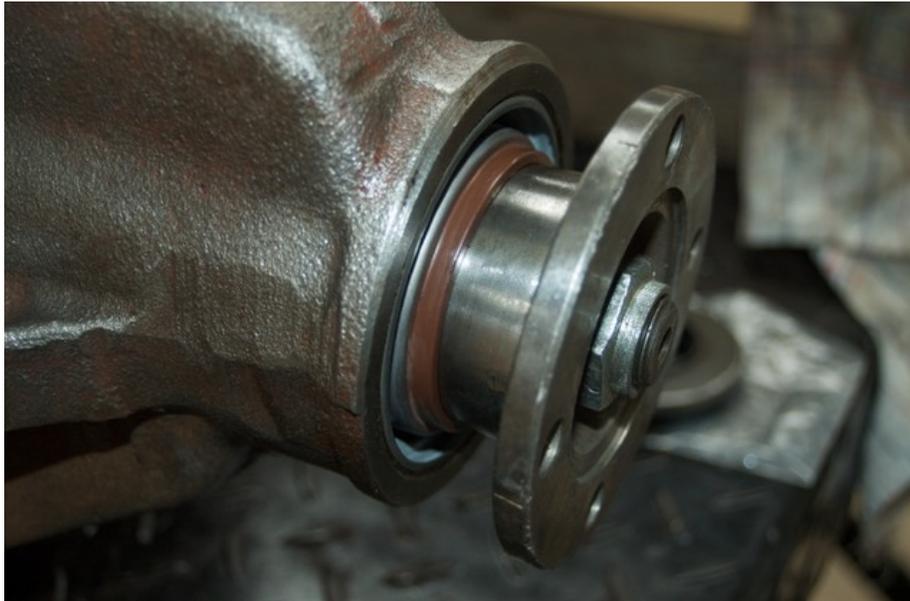
I did not trust my efforts of replacing the pinion seal; it looks kinda funny with the rubber **on** the axis instead of behind it. Add to that the fact the procedure could not be finished properly because of the front nut being loose to start with, I decided to have Kolvenbach take a look at it. Glad I did.

Not only was the pinion seal not installed properly, it was completely the wrong seal! On top of that the output shaft seals were also the wrong ones. A previous owner of the diff must have had the same problem as me.

Anyways, all seals replaced now by people who know what they are doing. The new pinion seal properly sits behind the flange now.

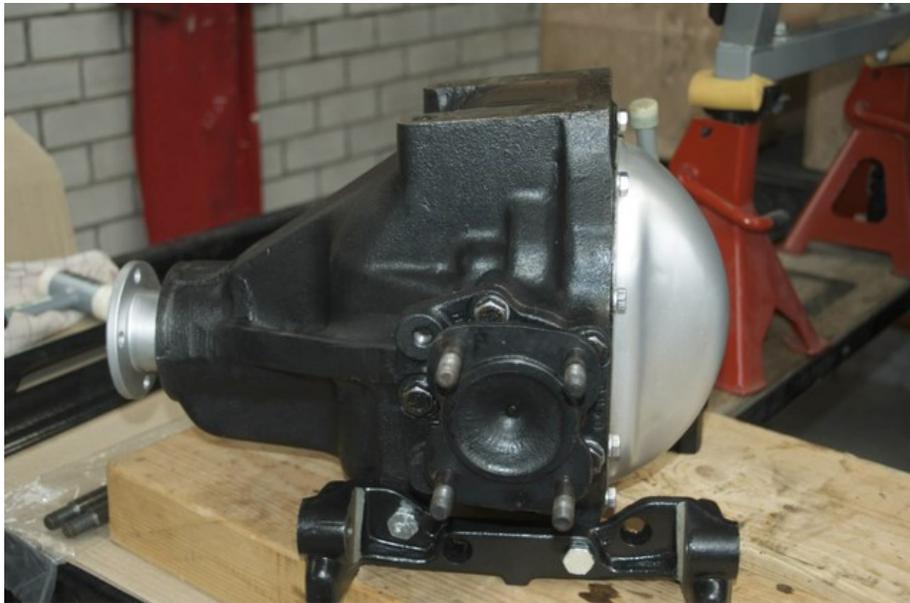
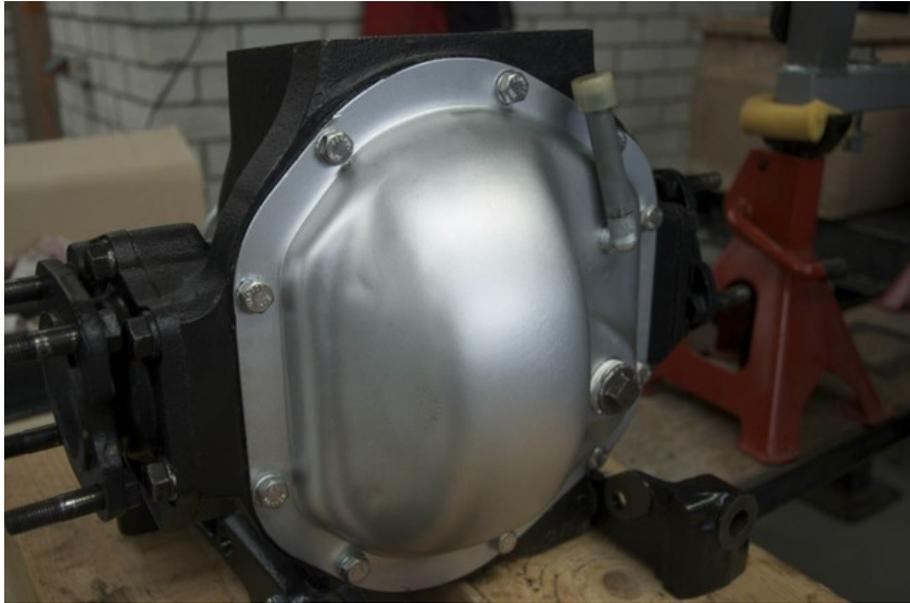
While they had the diff in parts I figured they could just as easily give it a spray. I rounded it off by installing the backplate with new stainless bolts and a diff we have!

I might give the base housing another spray, or use some POR chassis coat on it.
