Slow days

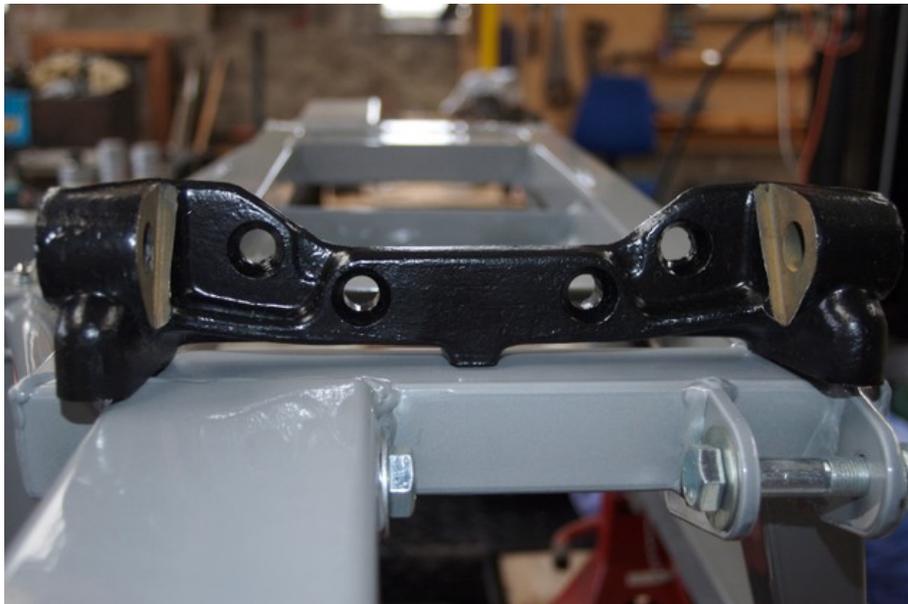
Steadily working on the donor parts, but days are a bit slow lately. Finishing the details of the garage takes its time as well. After treating the first donor parts, I'm not completely satisfied with the finish that por15 plus the chassiscoat leaves.

The por15 itself is very nice, glossy and very smooth, so that's nice, but the chassis coat ruins the bit by leaving stripes and not smoothing out. Have to think about how to go about that. The first thing is to add a bit of solvent to the chassis coat to make it smooth out a bit better.

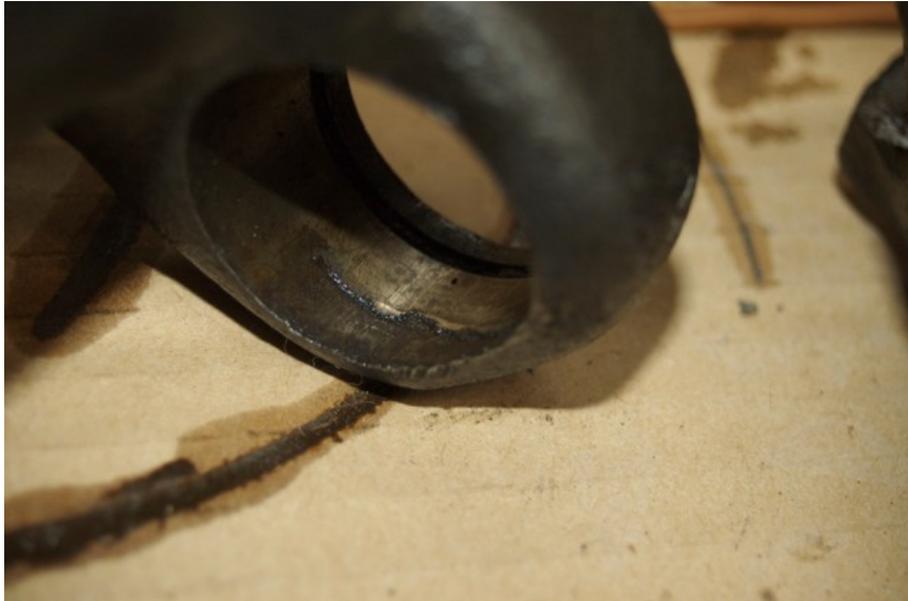
Next to that, inspecting the donor parts in detail reveals some things which need some attention. The parts are mostly in good condition, but obviously show their age and use.

One of the parts showed a worn (broken ?) inner wall. The other shaft had problems too but those I managed to repair to satisfaction. This one will have to be replaced.
