It should have been easier

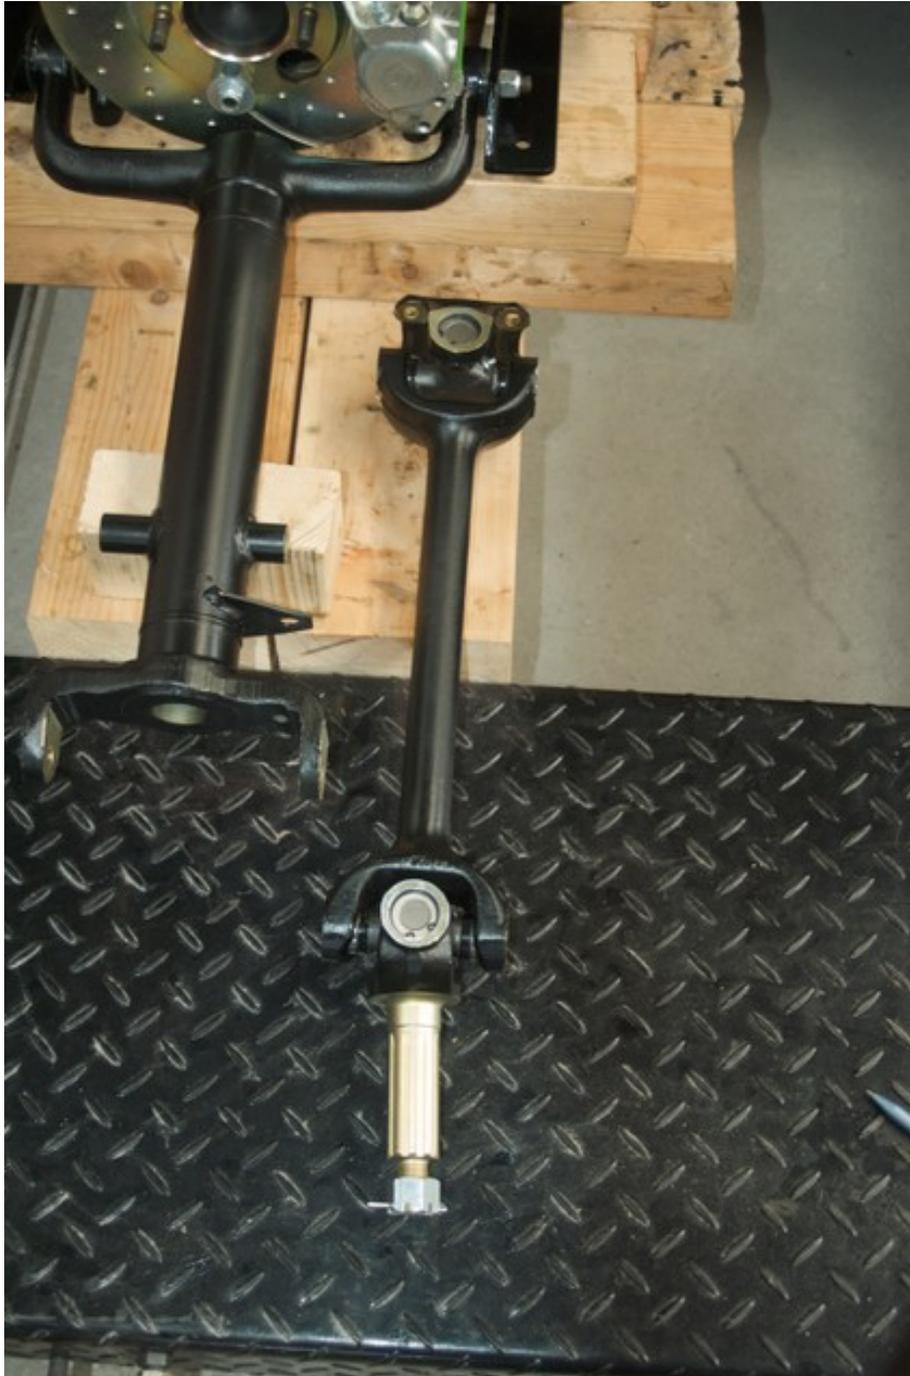
Assembling the rear driveshafts with the universal joints is an easy job (unlike the disassembly of them). Especially using my press, getting in the Universal Joints is very easy to do and the first was completed in no time.

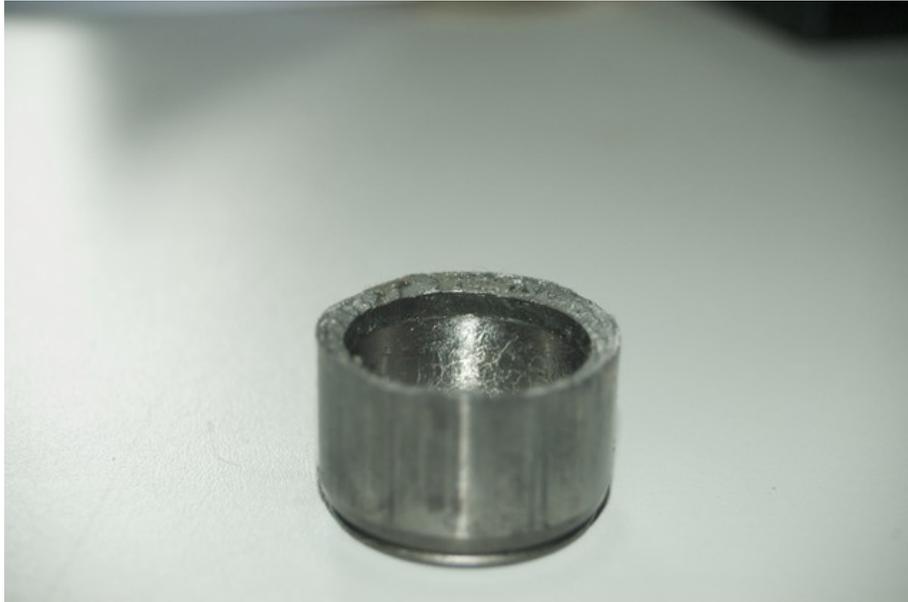
The second however, disaster! The first joint went in smoothly but when I

pressed in the second the complete "top lid" of one of the caps broke off!!! Aargh. No idea how this happened. I did not subject the joints to excessive force, although using a press sort of hides these forces.

So, after a minute or two of swearing I pressed out the one joint which, thankfully, did not damage the shaft and came out pretty easily. It should just be a matter of purchasing a new UJ now and pressing that in. All in all, the job took me 4 hours where it should have been like 10 minutes.
